ASPEN ART MUSEUM | ASPEN, USA

WOOD CONSTRUCTION

Project description

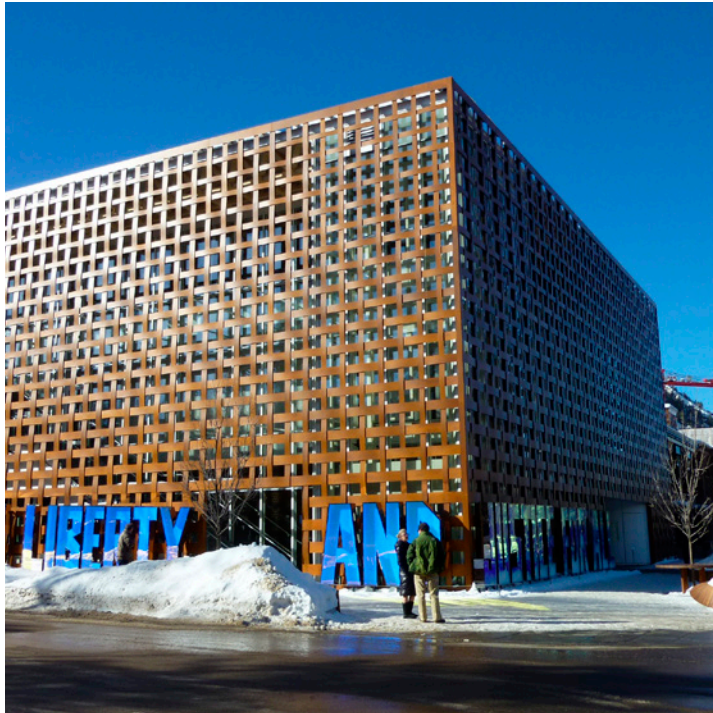
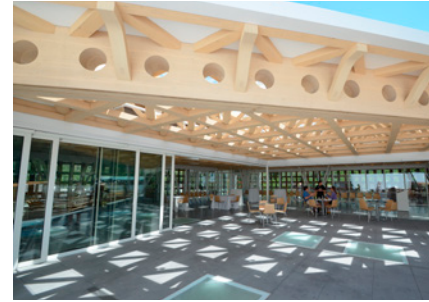
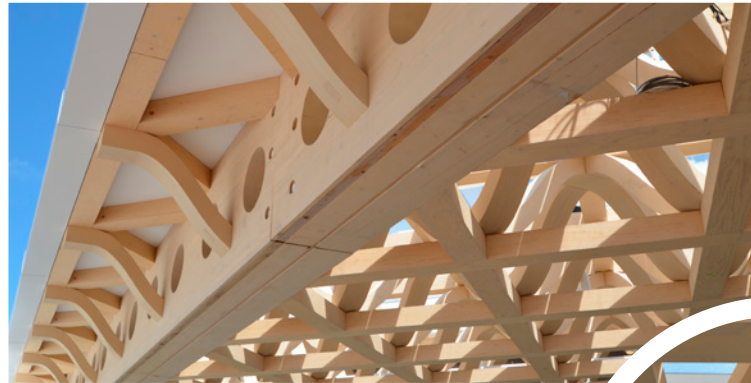
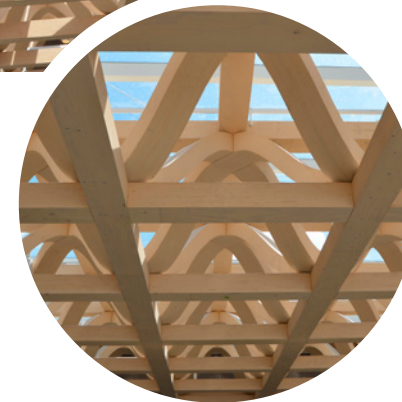
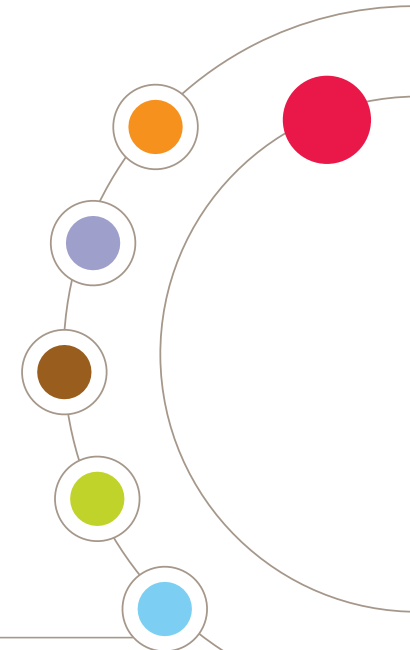
The roof construction of the museum consists of a space framework with wave-shaped plywood waves. The material is exposed to enormous snow loads as the building is located at about 2400 m above sea level. No standard material was able to meet the requirements, so panels were produced specifically for this project in Finland, tested and evaluated in Switzerland and installed in the Rocky Mountains.
